# TECHNICAL NOTE

## BH24FW016 - Eskdale Avenue

| Eskdale Avenue - Feasibility Study | BH24FW016 | July 2025 |
| TN001 | | |

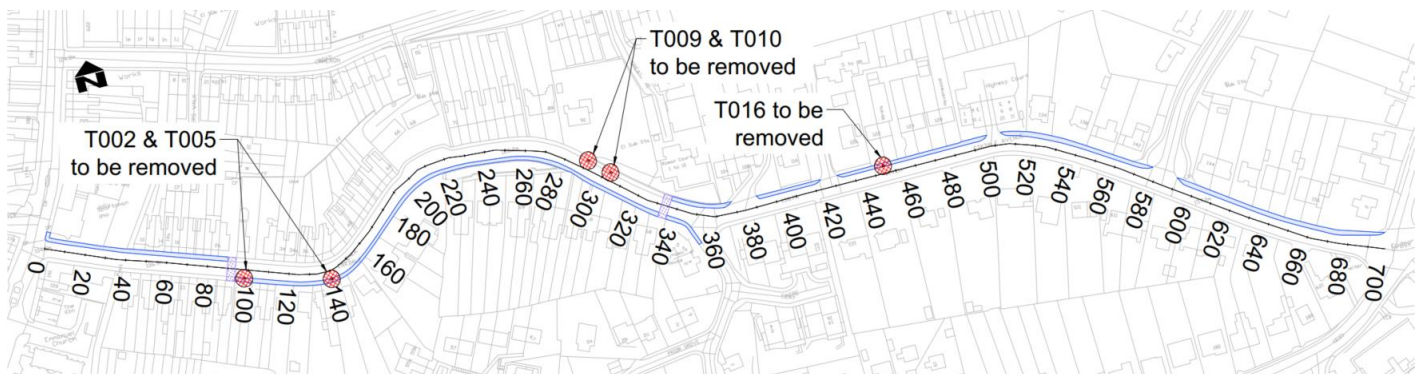
Figure 3 - Option B – Key Footway Route and Removal of 5 trees

- As shown in Figure 3, a route can be established for the full length of Eskdale Avenue. The footway surfacing for this area is to be of suitable width (min 1.8m), and to be free of any defects or damage.
- To facilitate the Key route, and to minimise the number of trees requiring removal, 2 no. Formalised crossing points are required a part of the design. These are to be installed in a location with adequate visibility and constructed as per BC specification.
- In the vicinity of the overgrown trees remaining in situ, the footway width remains restricted (1.0-1.5m max width)
- Footways which have been damaged by root ballasting require significant overlaying, however as shown in figure 2, some roots will remain above the footway surface.
- Pollarding may be required to be some trees, to slow unwanted growth.

In option B, the general proposal is to establish a ‘Key Footway Route’ along the full length of Eskdale Avenue, where the footway is free of obstruction and associated damage from Trees. The route requires the installation of 2 crossing points, as well as the removal of 3 no. healthy trees, to allow for the route. A sketch layout of this option can be shown in Figure 3.

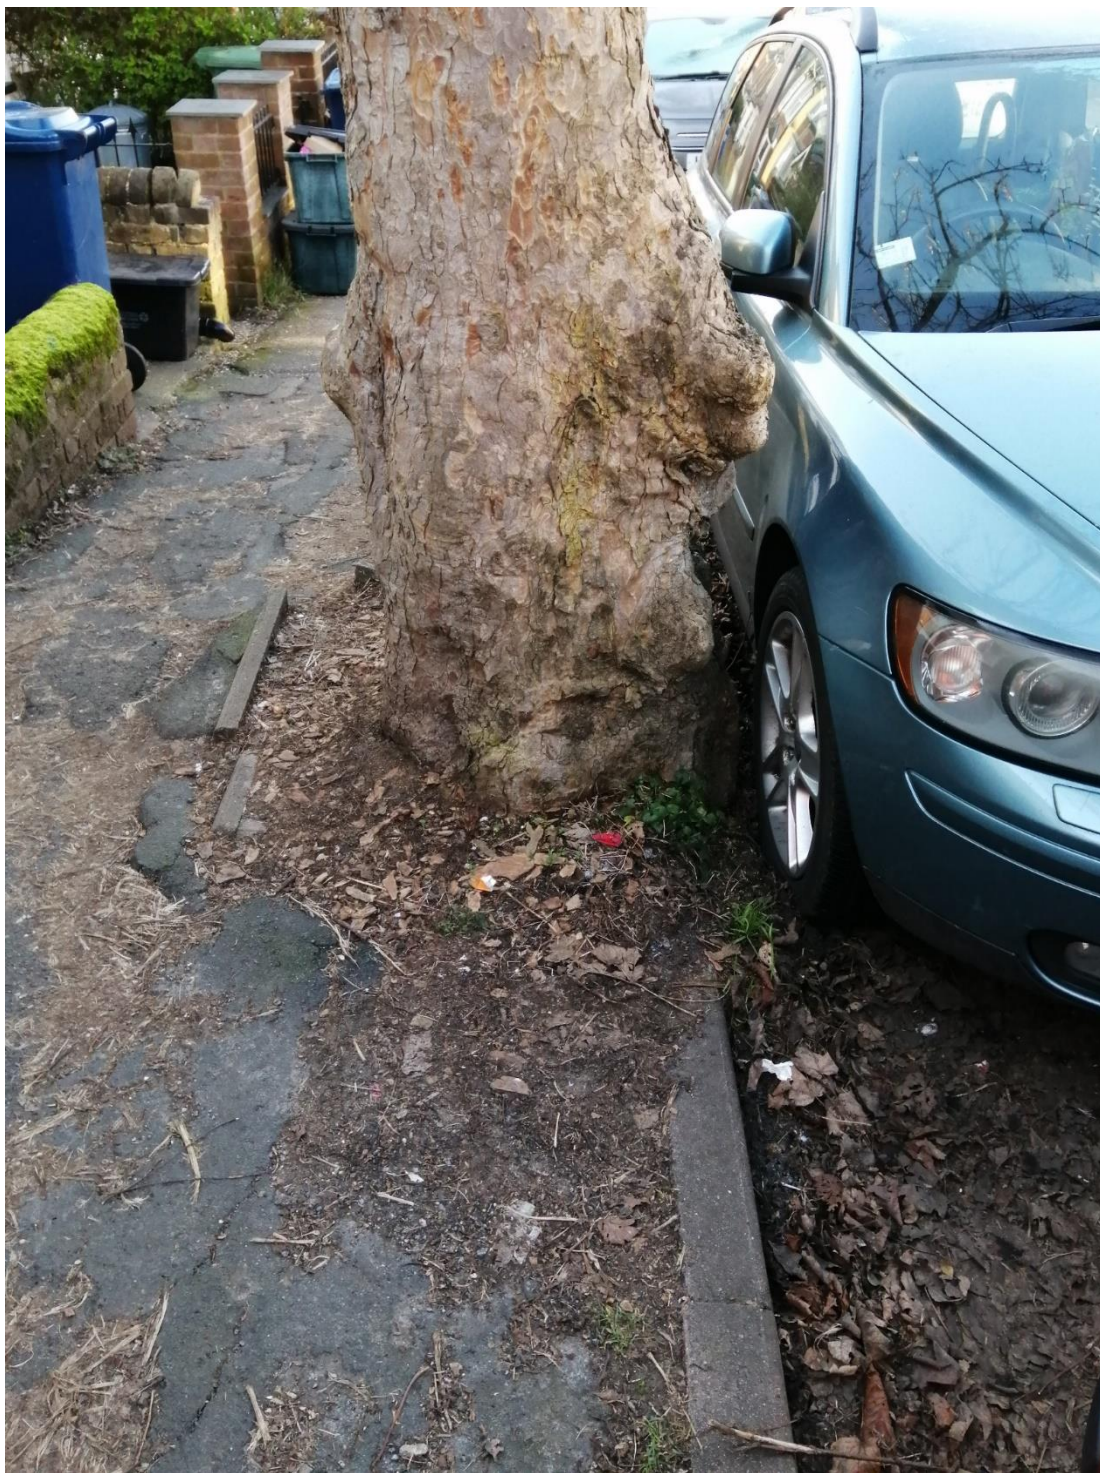
Figure 23: showing limited space for pedestrian passage, uneven surfacing and displaced edging units at the base of the sycamore T002.

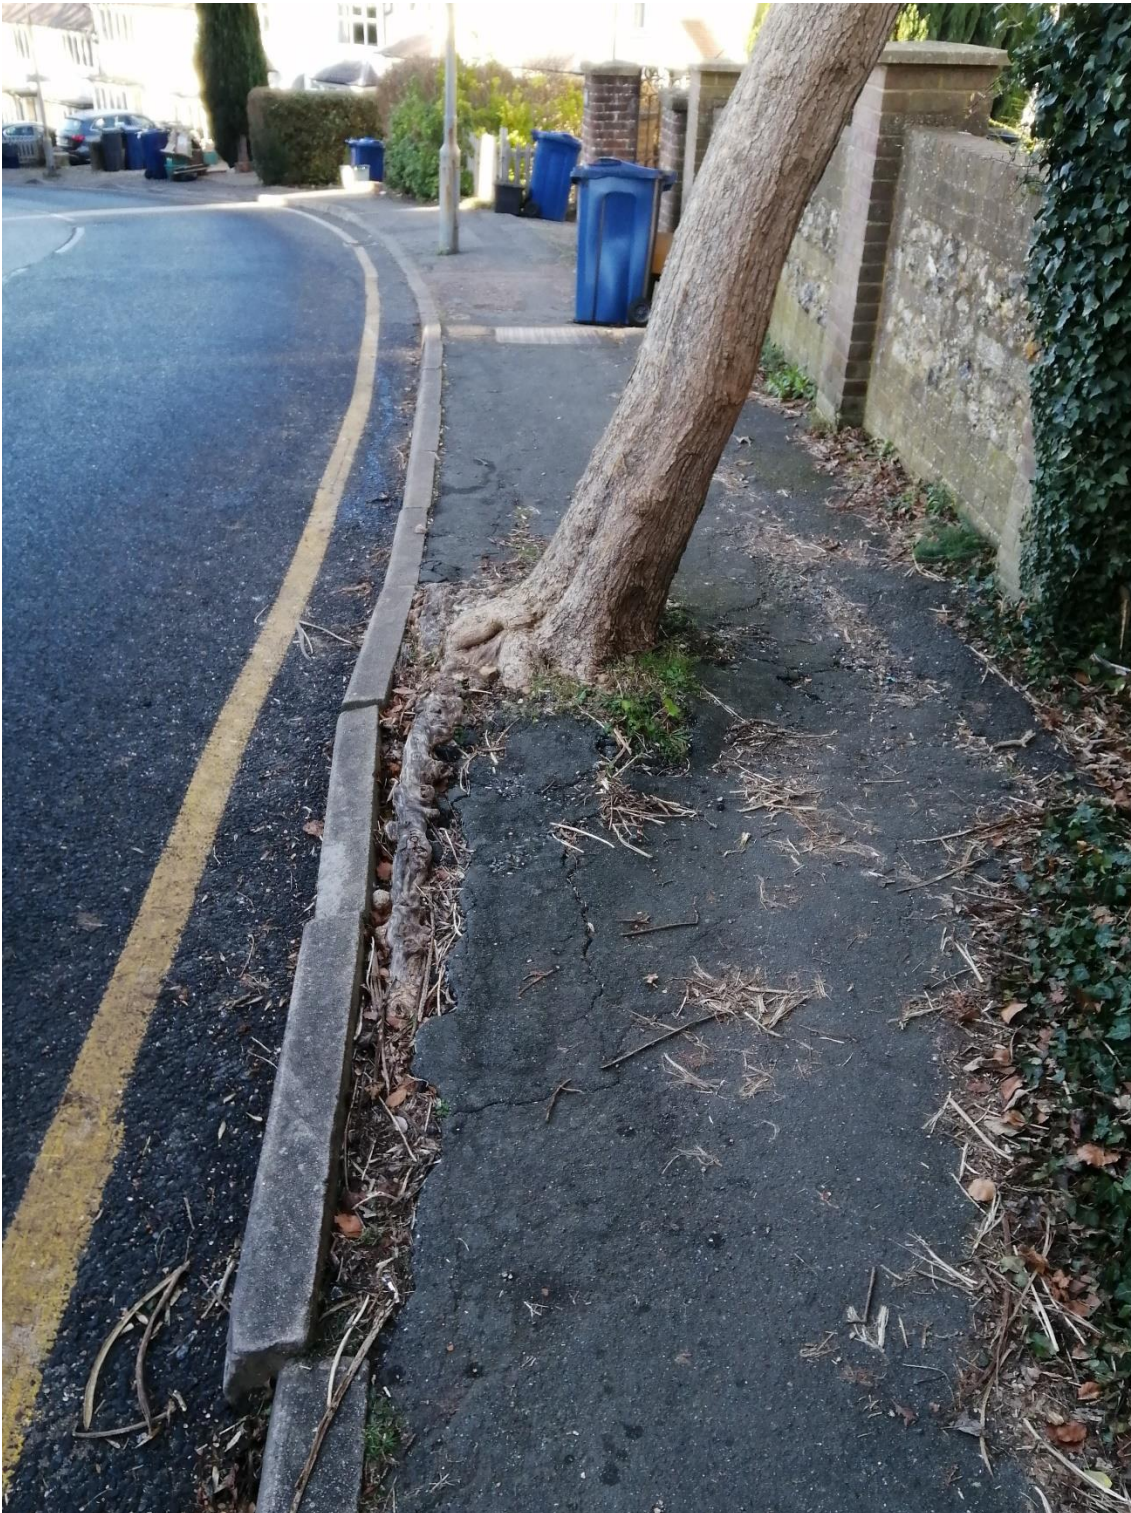
| Tree no. | Observations / Recommendations |
|---|---|
| <b>T009</b> | <p>This is a catalpa of modest size recorded as semi-mature. The stem has a pronounced lean to the north, with decayed basal roots extending along the kerb edge and displacing the kerbstones. The pavement surfacing is mounded at the base. Pedestrians with wider buggies are required to detour into the road to pass the tree.</p> <p>The primary concern here is the stability of the tree's rootplate. Imagery on Google Street View shows the base of the tree at different times dating back to 2008, but evidence of any movement of the rootplate is inconclusive.</p> <p>Were the tree to fall, it would fall towards the garden of a private residence. It is possible that the fall would be broken in part by a brick boundary wall and/or caught in adjacent vegetation. While the</p> |

| Tree no. | Observations / Recommendations |
|---|---|
| | <p>hazard might therefore be considered only moderate, there is a case to be made for the removal of the tree: the tree is unlikely to develop to full maturity due to the stem lean and the existing decay of the buttress roots, and its removal would also remove a significant barrier to pedestrian passage.</p> <p>If there is a will to retain the tree, then the lean might be addressed by crown pruning to lighten the load on the fall side of the tree; however, there is a limit to how much this could be achieved while maintaining an acceptable overall form to the tree. Consultation with the owners of the private residence may be appropriate.</p> |

**Figure 24: showing the leaning stem of the catalpa T009, with buttress roots extending along the kerb, causing displacement of kerbstones. Pedestrians with wider buggies must detour into the road to pass the tree.**

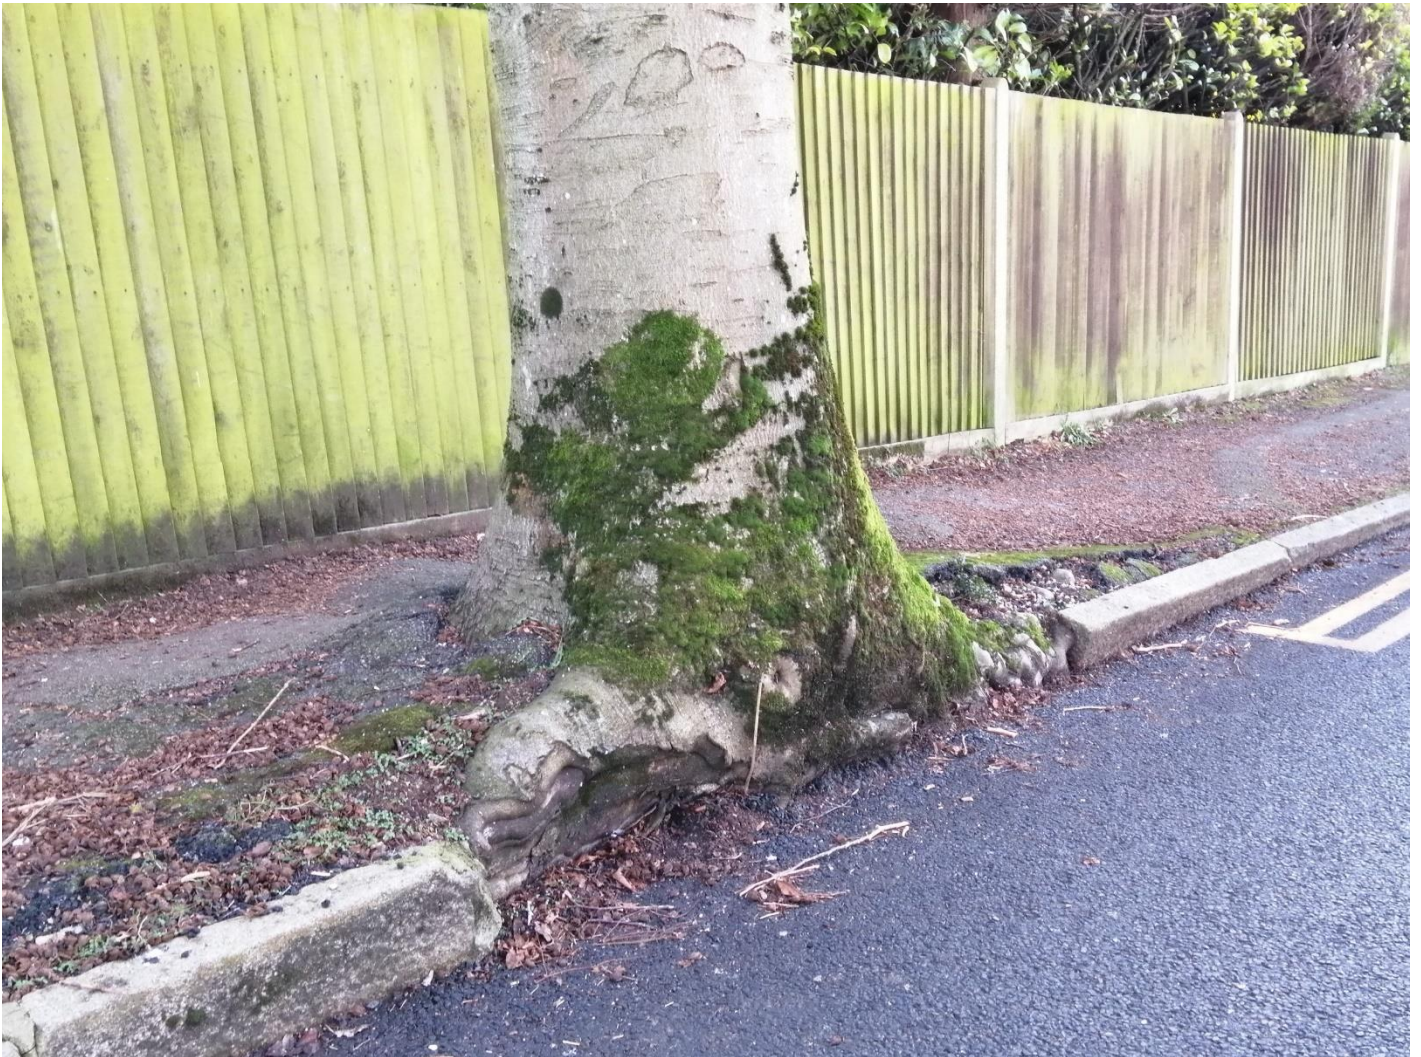
| Tree no. | Observations / Recommendations |
|---|---|
| <b>T013</b> | <p>Tree T013 is a mature beech tree at the pavement edge. Displaying good vitality at the time of the survey, it was recorded as a 'Category A' tree according to British Standard survey criteria - trees "of high quality with an estimated remaining life expectancy of at least 40 years".</p> <p>There is pronounced mounding and displacement of the pavement surfacing around the tree, which has received periodic tarmac patching. The tree's growing buttress roots appear to have accounted for the kerbstones at its base, which are missing. The void has been filled by the roots, which are showing established decay in places. The narrowness of the pavement here means that pedestrians with wider buggies are required to detour into the road.</p> <p>Given that no works involving excavation at the base of the tree are compatible with the retention of the tree, alternative solutions must be sought. One way to make the passage around the tree easier for all pavement users could be to extend the pedestrian space into the road area, so that the pavement passes the tree on the road side, not on the property boundary side. This would mean creating a short section where the pavement 'juts out' into the road – a kind of inverted lay-by. This could be achieved without excavation, as the ground level could be built up above the existing road surface, after removal of the current road surface. The pavement on the property boundary side of the tree could also be taken up, to create a larger area of soft ground and improved future growing conditions for the tree (and also for any subsequent tree that might at some future date replace the current tree).</p> <p>Such a solution would of course have significant implications for vehicle users, but could perhaps be implemented as part of traffic-calming measures that might encourage motorists to drive at speeds appropriate for a residential road near to a school.</p> <p><i>With a stem diameter of 700mm, the tree is in the early stages of maturity. As such, the estimated life expectancy of the tree could be thought to justify the cost of works to improve the pedestrian experience in the area adjacent to this tree.</i></p> |

**Figure 25: the beech tree T013, showing buttress roots occupying the space vacated by kerbstones. Space for pedestrians between the tree and the boundary fence is limited.**

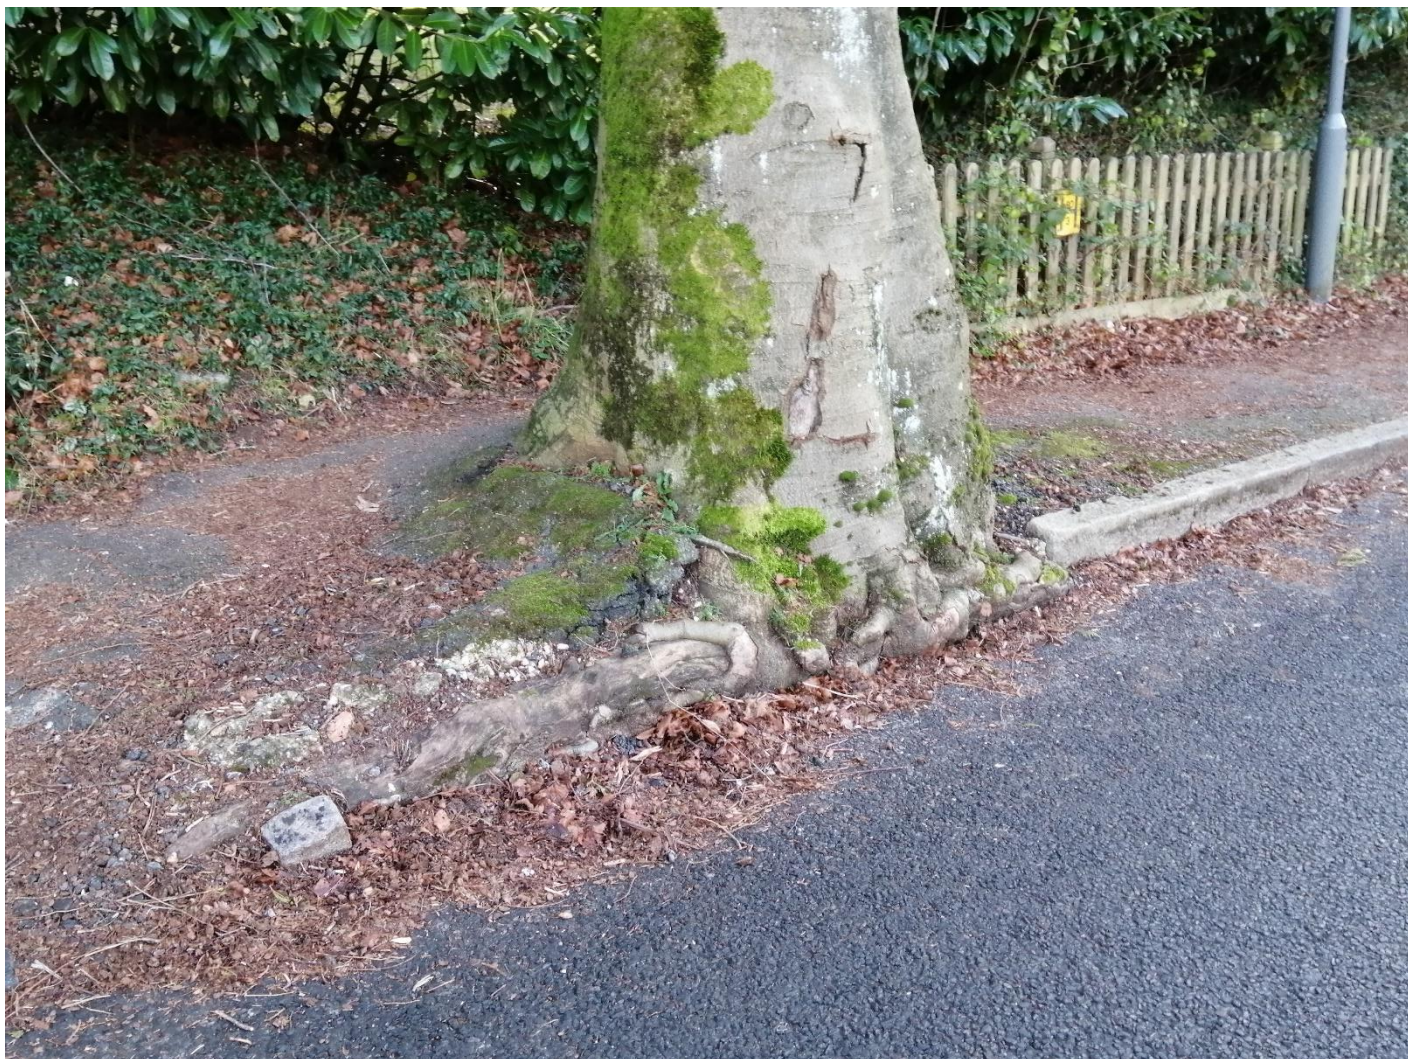
| Tree no. | Observations / Recommendations |
|---|---|
| <b>T015</b> | <p>Like T013, tree T015 is a mature beech tree at the pavement edge. Displaying good vitality at the time of the survey, it was recorded as a 'Category B' tree according to British Standard survey criteria - "of moderate quality with an estimated remaining life expectancy of at least 20 years".</p> <p>There is pronounced mounding and displacement of the pavement surfacing at the tree base, with buttress roots occupying the space vacated by kerbstones. Desiccated ripewood decay as observed on the buttress roots, and there is a distinctive protruding knobble 150mm above the pavement surface on a root to the west of the stem.</p> |

| Tree no. | Observations / Recommendations |
|---|---|
| | <p>Considerations for improving the pedestrian experience around this tree are very similar to those for T013: an innovative solution must be found if the tree is to be retained. However, a possible constraint for T015 is that it is located directly opposite T016 – another tree in a similar situation. Of the two trees, T015 is superior in terms of both size and physiological health.</p> <p>With a stem diameter of 670mm, the tree is in the early stages of maturity. <i>As such, the estimated life expectancy of the tree could be thought to justify the cost of works to improve the pedestrian experience in the area adjacent to this tree.</i></p> |

**Figure 26: Tree T015, showing limited space for pedestrian passage between the tree and the property boundary behind. Buttress roots have filled the space where kerbstones may once have been.**

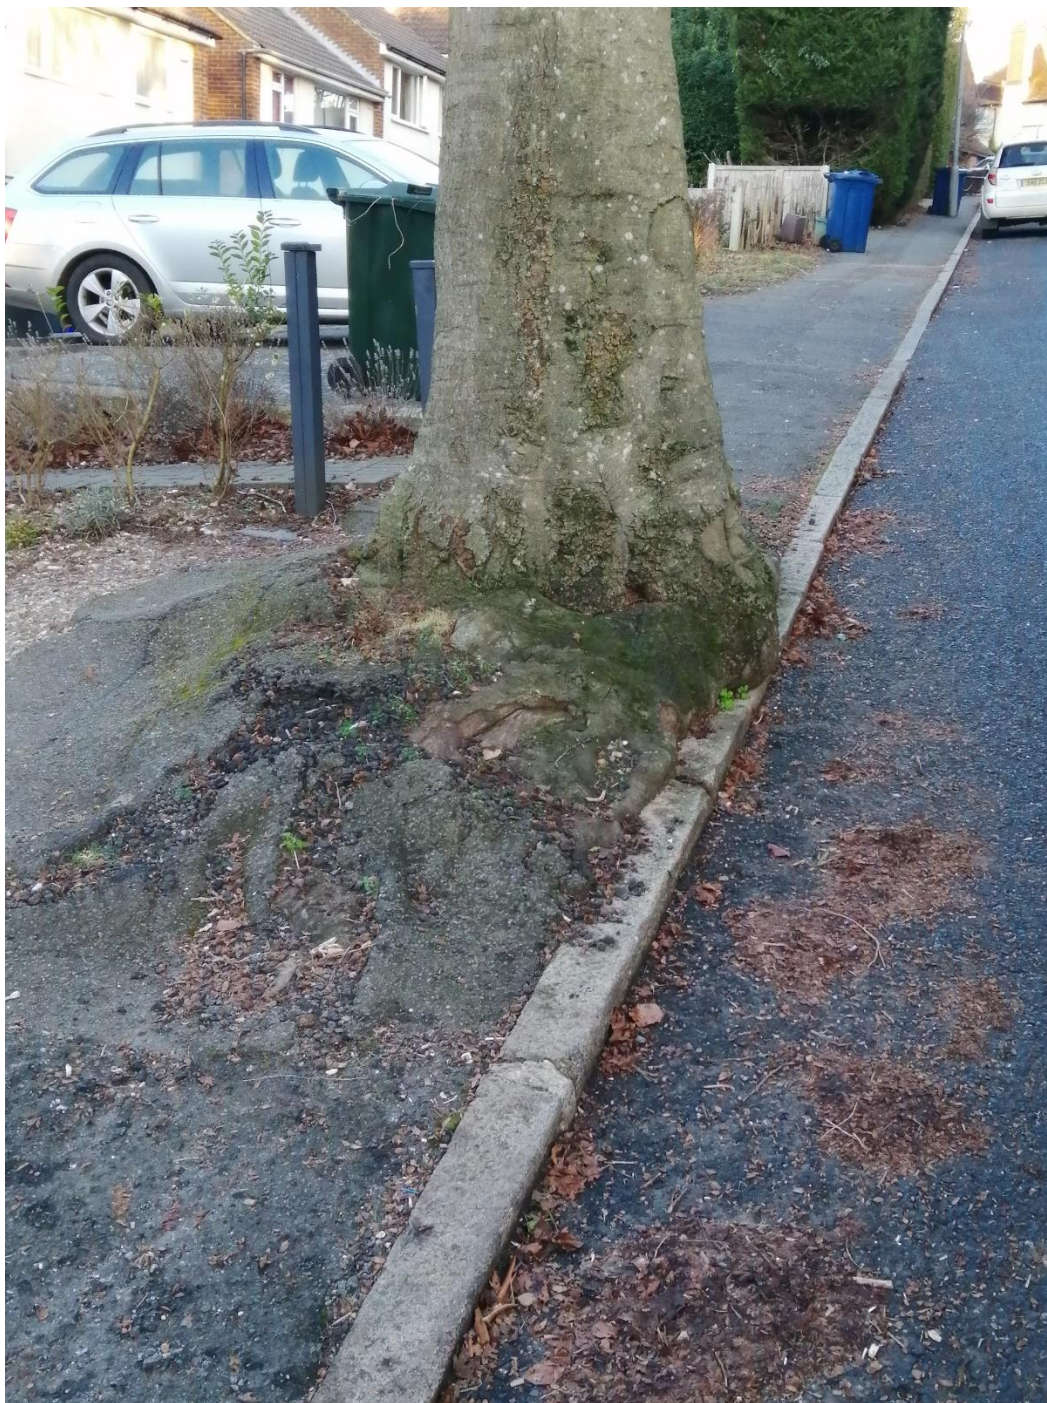
| Tree no. | Observations / Recommendations |
|---|---|
| <b>T016</b> | <p>Tree T016 is another mature beech tree at the pavement edge. Displaying fair vitality at the time of the survey, it was recorded as a 'Category B' tree according to British Standard survey criteria - "of moderate quality with an estimated remaining life expectancy of at least 20 years".</p> <p>The tree has a slightly sparse crown, with pockets of established decay at crown-lifting wounds; further crown pruning has taken place associated with telecomms cables that pass close to the crown.</p> <p>There is very pronounced mounding and displacement of the pavement surfacing at the base of the tree. Buttress roots extend along the kerb, occluding over but not displacing the kerbstones. There is desiccated ripewood decay on the buttress roots. There is a history of extensive trench work around the tree (which may be seen on Google Street View imagery from 2008).</p> <p>Considerations for improving the pedestrian experience around this tree are very similar to those for T013: an innovative solution must be found if the tree is to be retained. However, a possible constraint for T016 is that it is located directly opposite T015 – another tree in a similar situation. Of the two trees, T015 is superior, as stated above.</p> |

**Figure 27: the kerbstones remain in place beside tree T016, but the narrowness and pronounced mounding of the pavement means there is no easy passage for pedestrians.**
