Buckinghamshire County Council

Hicks Farm Rise Traffic Calming

Feasibility Study Report

LOC18015/FEA/DOC/01

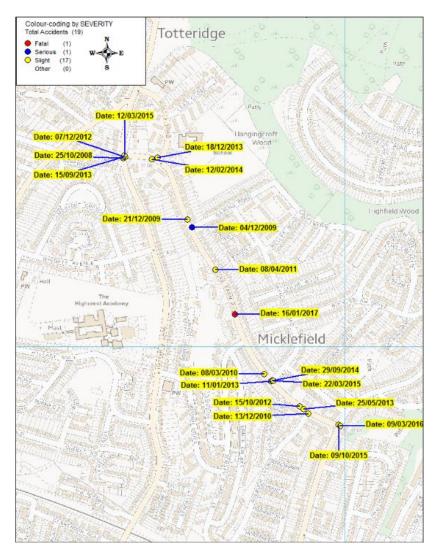
Figure 1
Hicks Farm Rise – recorded injury collisions from 2008 to 2018

- 5.1.1 A summary of the reported 10 years reported injury collision record along Hicks Farm Rise is included within Appendix A.
- 5.1.2 Figure 1 shows the locations of these injury collisions.

- 5.1.3 It is interesting to note that most collisions appear to have occurred in the vicinity of existing junctions these being areas where vehicle paths would conflict the most. It is possible that vehicle speeds could be a contributory factor to the collisions at these existing junctions.
